# CORRUGATED ROOFING

## INTRODUCTION

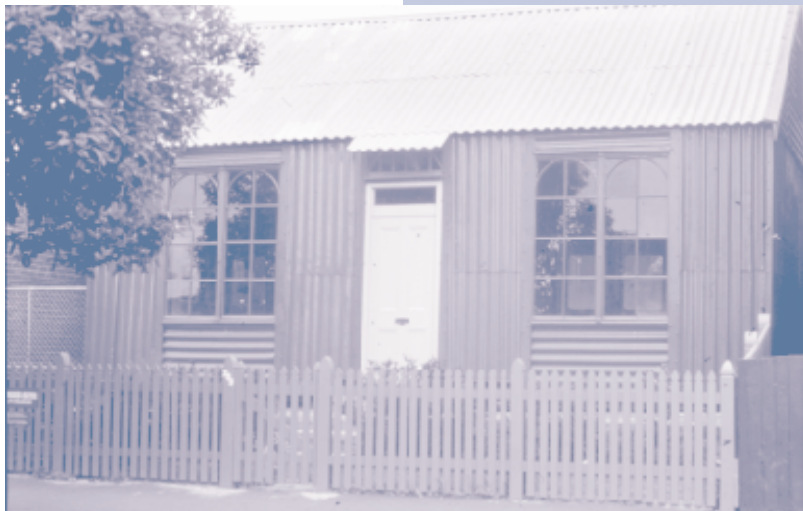
*The iron house in South Melbourne has a wrought-iron frame clad with corrugated sheet. One of many imported to Victoria during the gold rush, this is now one of the few surviving prefabricated iron houses in the world.*

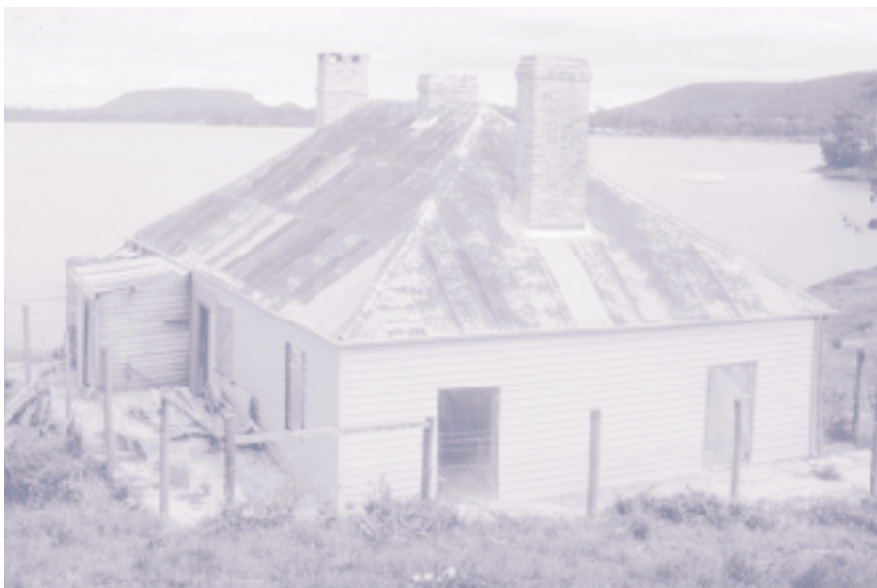
*Photograph by David Wixted*

*An appropriate re-sheeting of this building in shorter length sheets will preserve the architectural scale of the building's appearance.*

These advantages need to be weighed against the change in appearance that full-length sheets bring. On steeply sloping roofs of short sheets the joints can be seen as the shadow line of the overlapping sheet, and less obviously, the additional nailing needed at the join. These provide a distinct horizontal element to the appearance of many roofs and their loss may lead to a change in the character of the roof. On the other hand, there can be little objection to full-length sheets on planes of a roof that are not readily visible.
